Playdale Playgrounds

Post Installation Report

Swalcliffe Parish Council

Swalcliffe Play Area
Main Road , Banbury , Oxon , OX15 5EP

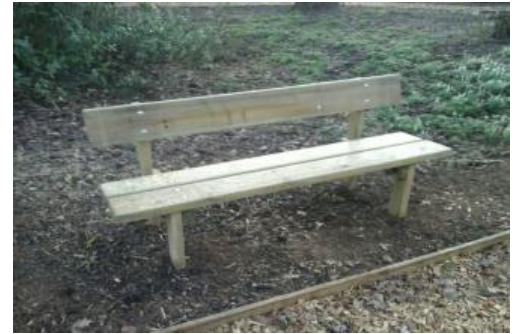
Item: Bench
Manufacturer: Playdale Playgrounds Ltd
Surface Type: Soil
Equipment Compliance: N/A
Surface Area Compliance: N/A

This item is satisfactory - no work required -

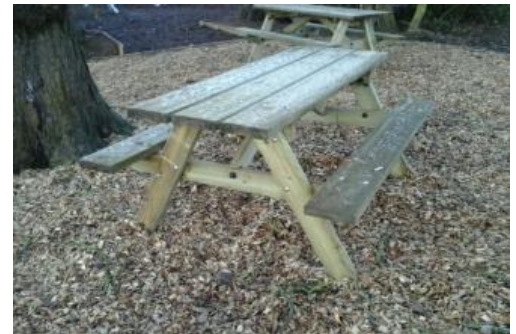
Item: Picnic Table
Manufacturer: Playdale Playgrounds Ltd
Surface Type: Woodchip
Equipment Compliance: N/A
Surface Area Compliance: N/A

This item is satisfactory - no work required -

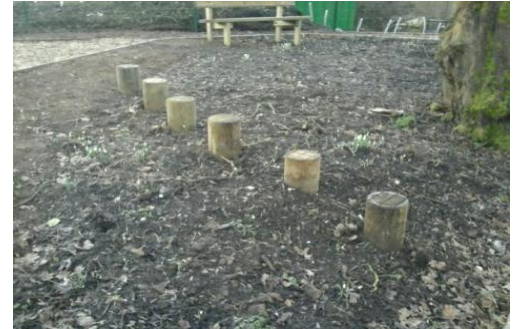
Item: Stepping Stones
Manufacturer: Playdale Playgrounds Ltd
Surface Type: Soil
Equipment Compliance: No
Surface Area Compliance: Yes

The timber edgings and top step are protruding above ground level and form hard objects within the falling space of the equipment in contravention of the requirements of BS EN 1176 Part 1 - Reinstate the surrounding surface to level with the edgings, chamfer the step end and monitor use

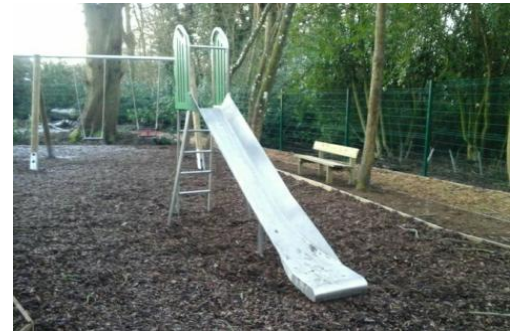
Item: Free Standing Slide
Manufacturer: Playdale Playgrounds Ltd
Surface Type: Bark Mulch
Equipment Compliance: Yes
Surface Area Compliance: Yes

There is no identification label affixed to the equipment - Provide an identification label

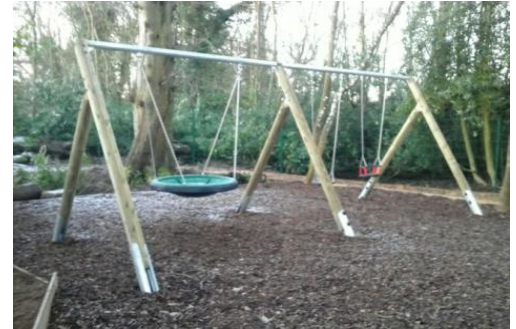
Item: 2 Bay Swing
Manufacturer: Playdale Playgrounds Ltd
Surface Type: Bark Mulch
Equipment Compliance: Yes
Surface Area Compliance: Yes

The bark levels are low in one corner and are lower than the proposed finished ground level markers, this has resulted in the seats being relatively high - Top up bark levels

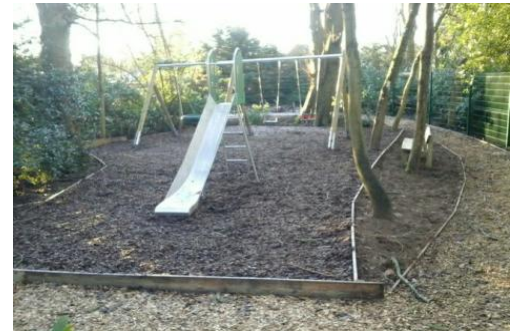
The installation of the sign is incomplete - Complete installation and provide a sign in accordance with the recommendations set out in BS EN 1176

The landscaping and site clearance works are incomplete, this includes the turf around the stepping stones and benches - Complete installation and site clearance works

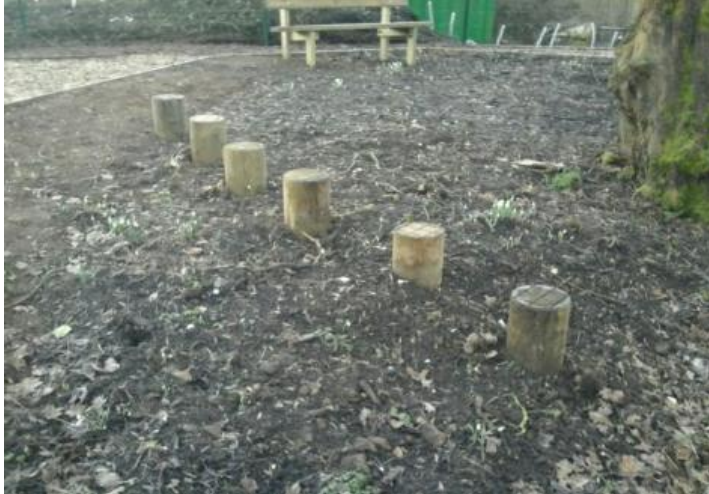
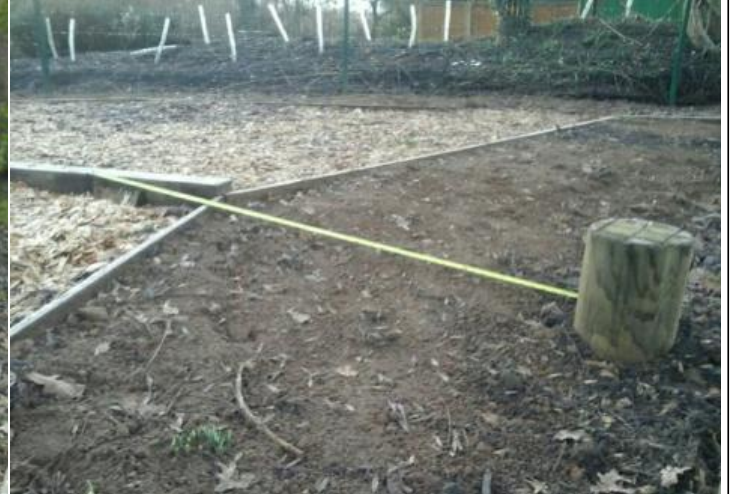
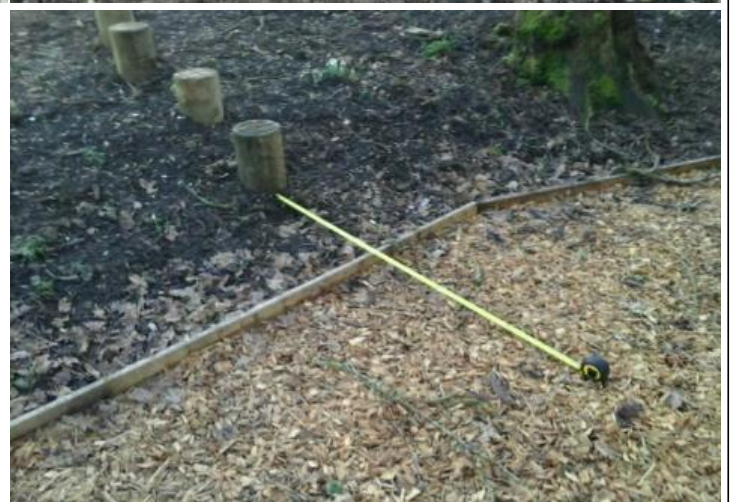
Item: Activity Equipment - Stepping Stones
Manufacturer: Playdale Playgrounds Ltd

Finding: The timber edgings and top step are protruding above ground level and form hard objects within the falling space of the equipment in contravention of the requirements of BS EN 1176 Part 1

Action: Reinststate the surrounding surface to level with the edgings, chamfer the step end and monitor use

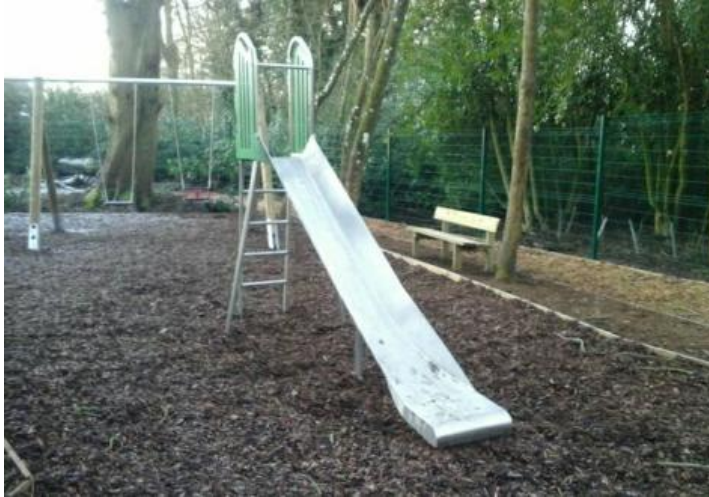
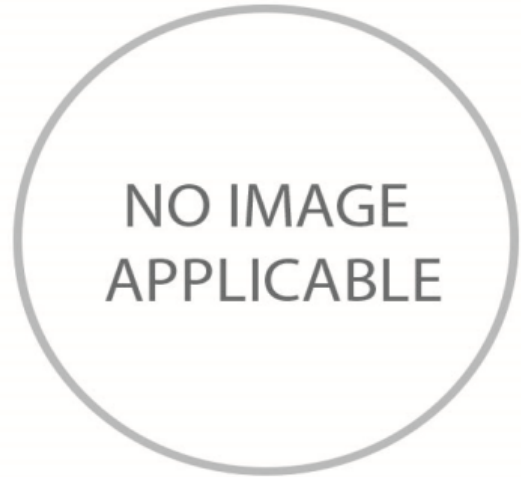
Item: Other - Free Standing Slide
Manufacturer: Playdale Playgrounds Ltd

Finding: There is no identification label affixed to the equipment

Action: Provide an identification label

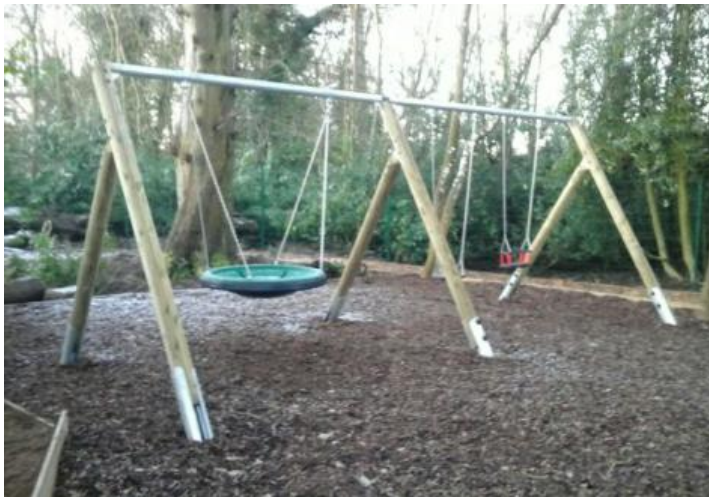
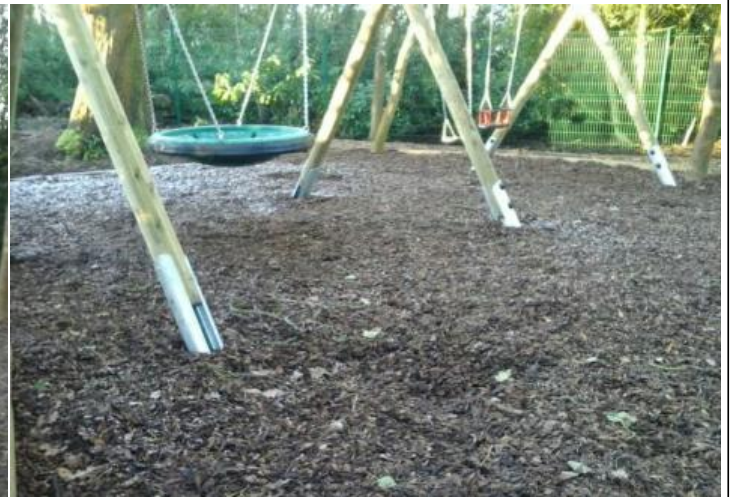
Item: Swings - 2 Bay Swing
Manufacturer: Playdale Playgrounds Ltd

Finding: The bark levels are low in one corner and are lower than the proposed finished ground level markers, this has resulted in the seats being relatively high

Action: Top up bark levels

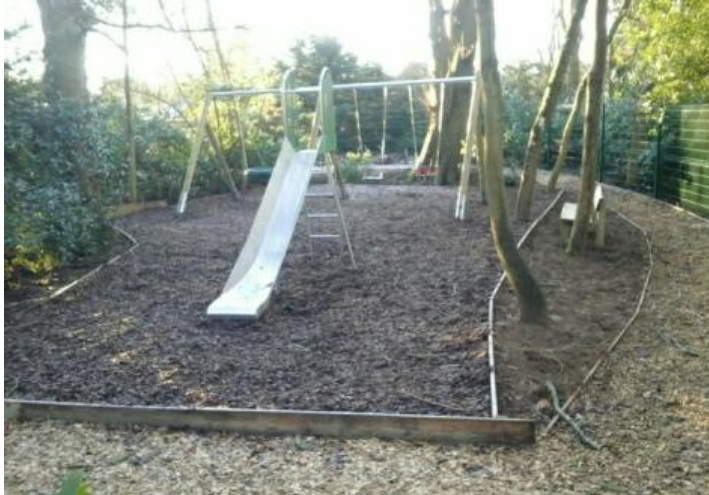
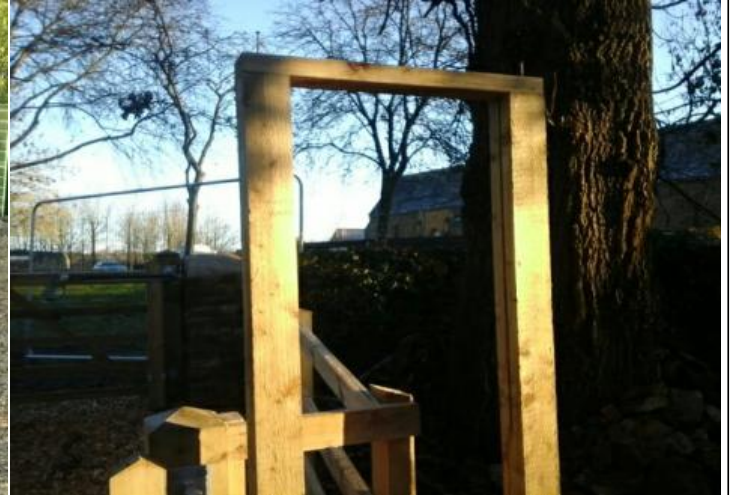
Item: Ancillary Items - Site General
Manufacturer: Owner/Operator

Finding: The installation of the sign is incomplete

Action: Complete installation and provide a sign in accordance with the recommendations set out in BS EN 1176

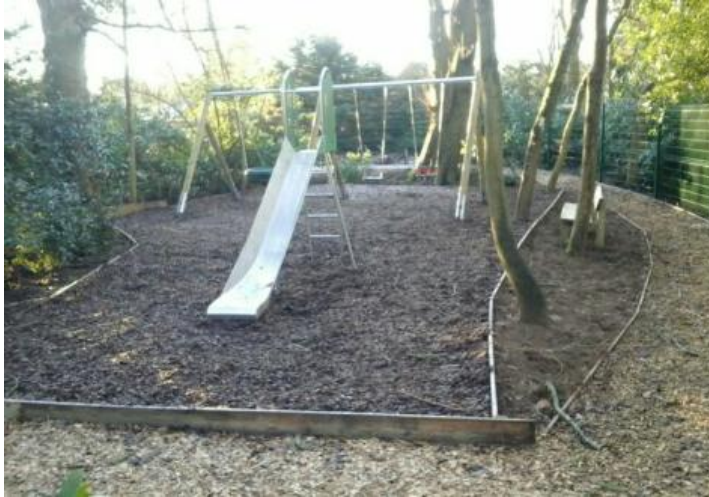
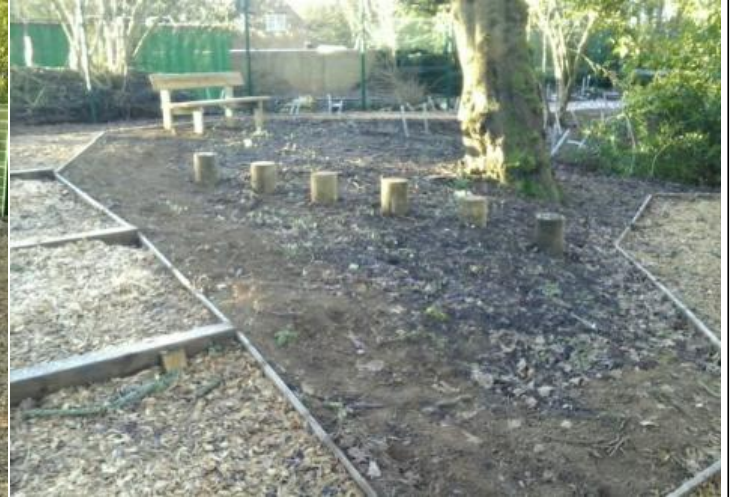
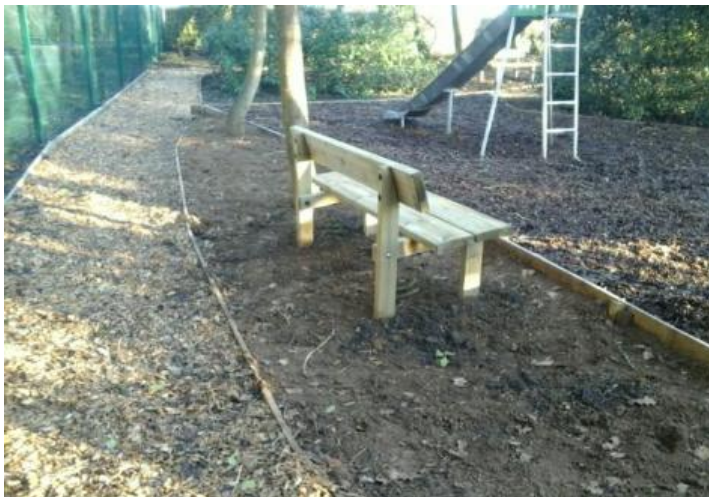
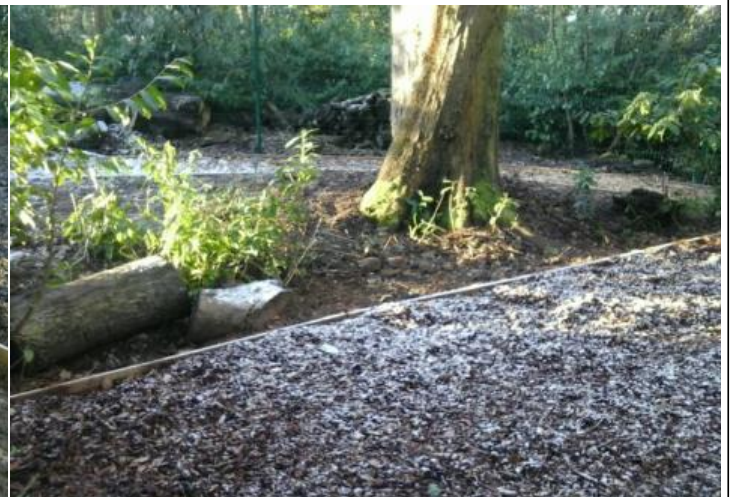
Item: Ancillary Items - Site General
Manufacturer: Owner/Operator

Finding: The landscaping and site clearance works are incomplete, this includes the turf around the stepping stones and benches

Action: Complete installation and site clearance works
